Geomorphology Report on Coastal Erosion at the Detention River Estuary, Hellyer, North West Tasmania

By
Joanna Ellison¹, Margaret White, Michael Poole,
Kim Beasy, Sarah McNab, and Hannah Walford

15 July 2010

Report to Crown Land Services Branch, Department of Primary Industries, Parks,
Water and Environment, Lands Building - Level 5, 134 Macquarie Street, Hobart,
Tasmania 7000

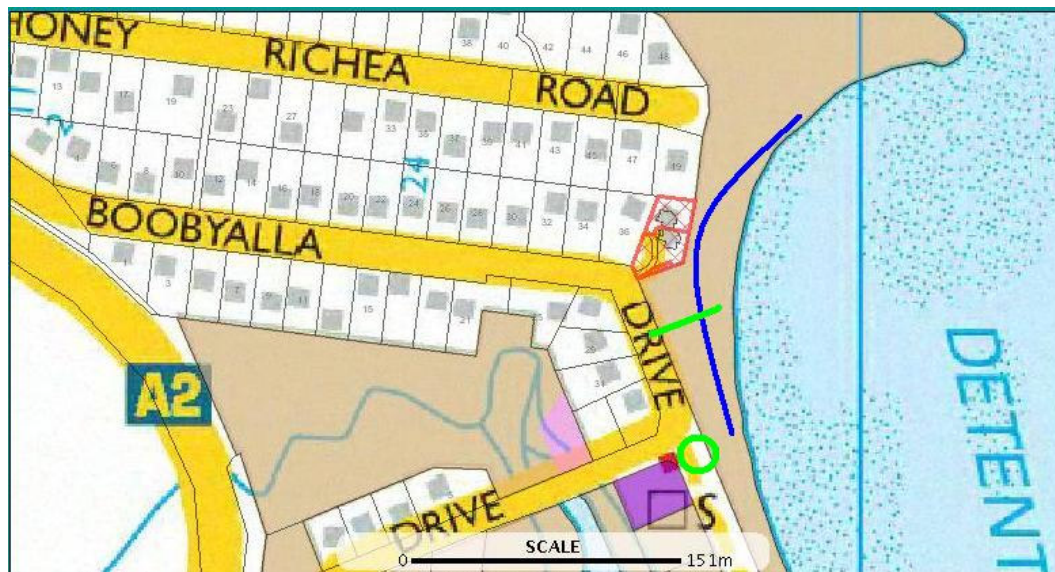
Figure 1: Map of erosion site (from Crown Land Services, 2010).

Key: Blue line: approx. location of erosion bank; Brown: Crown Land; White: Freehold. Red: Most affected properties; Purple: Fire station.

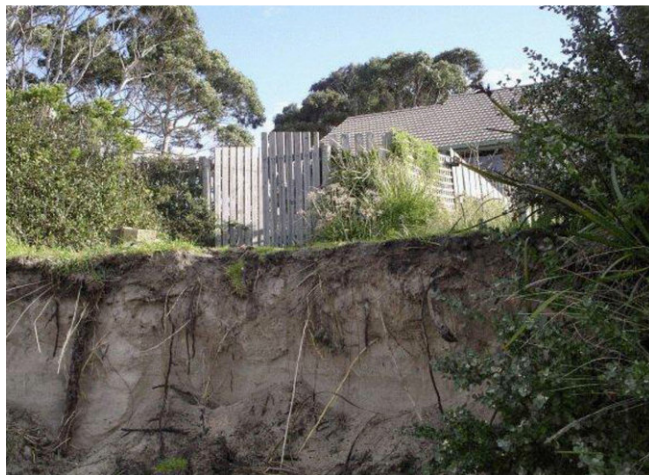
Figure 2: From the Detention River foreshore a look at the vertical bank erosion outside the property of Unit 1 and 2, 38/40 Boobyalla Drive, Hellyer (ABC News, 4 March 2010).

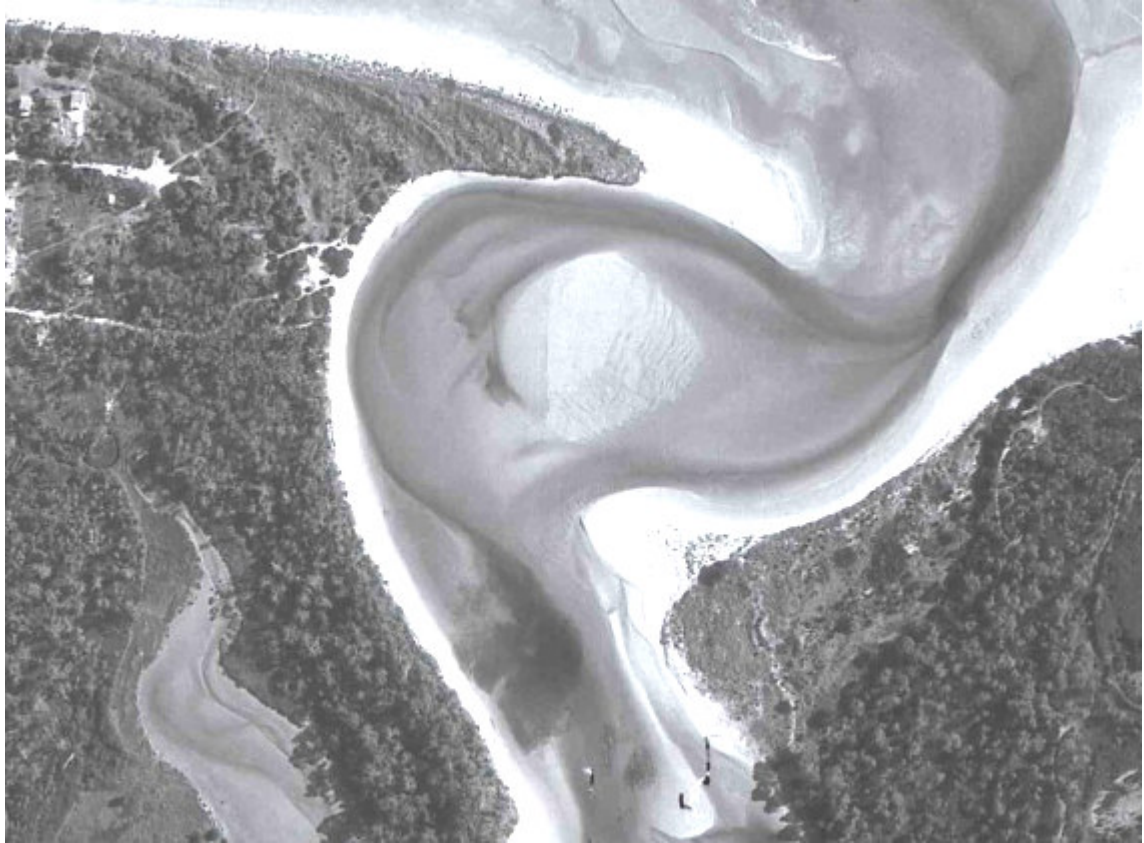
Figure 5. Detention Estuary mouth in 1968 (from DPIPWE image 1968-507-9).

Figure 5 taken in 1968 shows the main estuarine channel to the west, with greater width and it seems depth as demonstrated by darkness of colour than a smaller channel to the east. In the centre of the estuary mouth to the south of the NW sand spit is a sand bank. Later images will be described relative to this baseline.

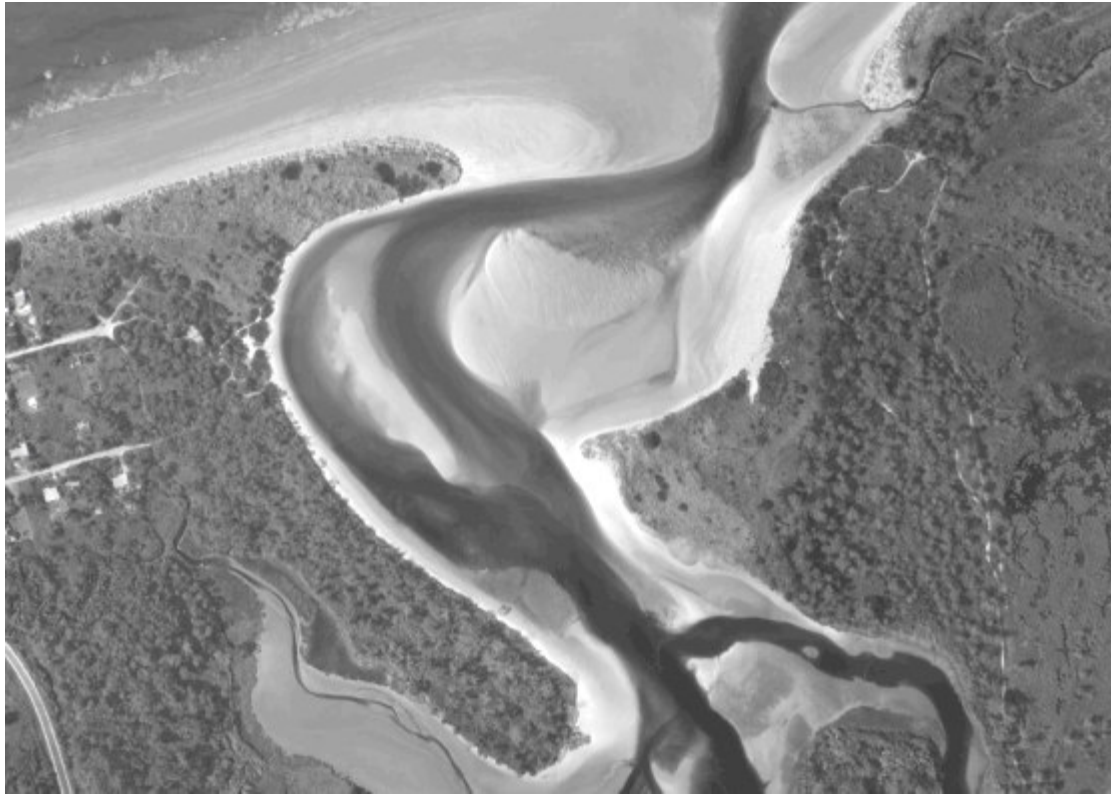
Figure 6. Detention Estuary mouth in 1971 (from DPIPWE image 1971-582-67).

Figure 6 taken in 1971 shows the main estuarine channel in the centre, with greater width and it seems depth as demonstrated by darkness of colour than a smaller channel to the west. This central channel passes to the west of a sand bank in the centre, and relative to 1968 has caused erosion to a sand spit to its south east. The estuarine channel in the east seen in the 1968 photograph seems to have closed with sediment deposition.

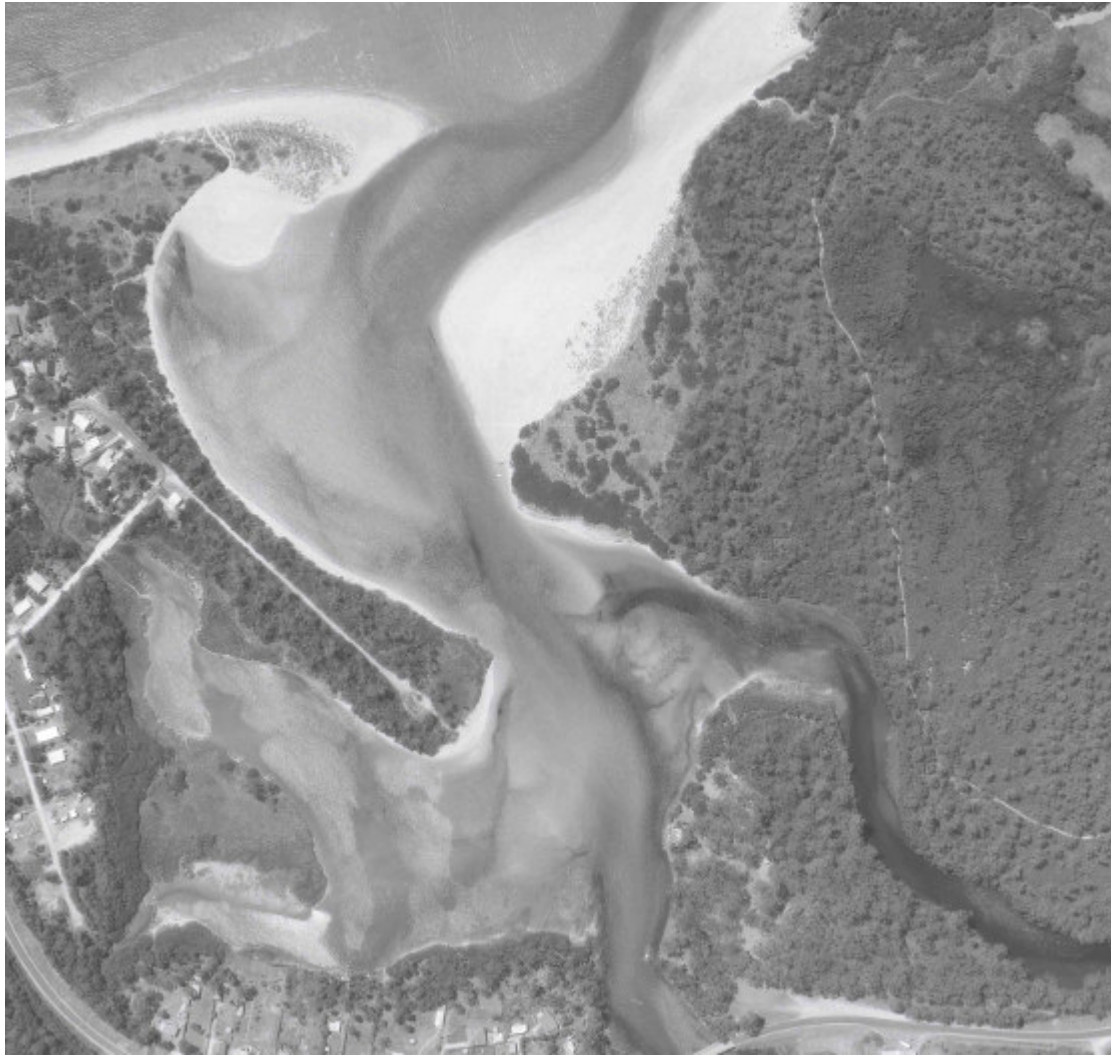
Figure 7. Detention Estuary mouth in 1988 (from DPIPWE image 1988-1098-116).

Figure 7 taken in 1988 shows the main estuarine channel in the centre, with greater width and it seems depth as demonstrated by darkness of colour. The central sand bank visible in the 1968 and 1971 images seems to have gone. There has been further erosion to the sand spit to its south east, but to the north east there has been continued beach progradation. The NW sand spit point seems to have lost vegetation from its end and recurved south relative to the 1971 image. On this 1988 photograph there does not seem to be a deep channel adjacent to the erosion site problem area to the west, with predominant flow through the centre of the estuary.

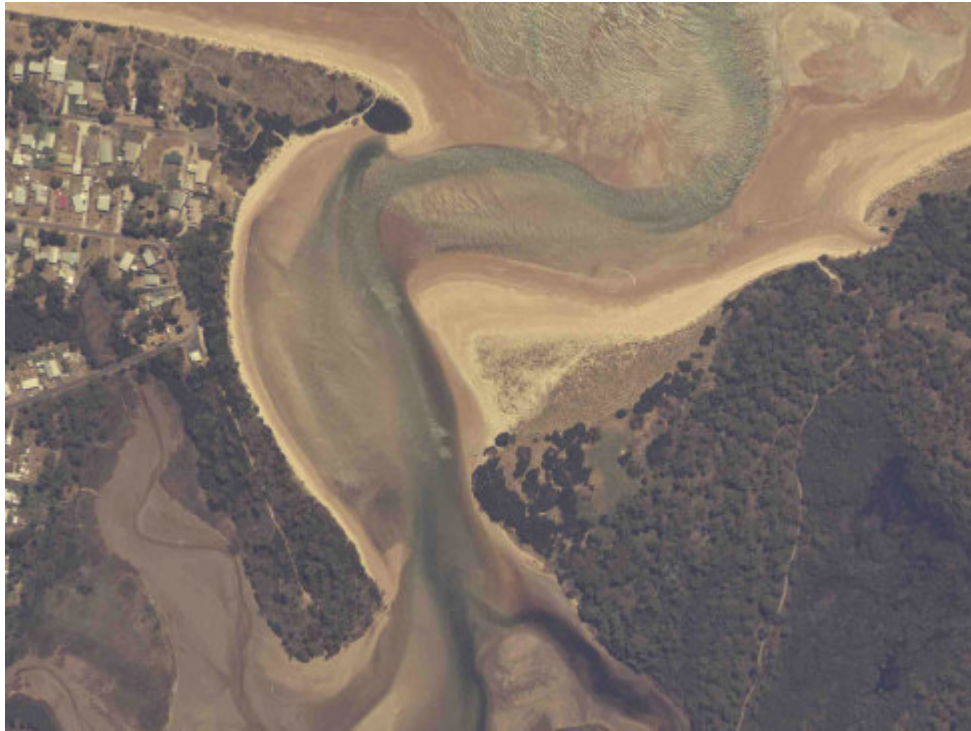
Figure 8. Detention Estuary mouth in 1997 (from DPIPWE image 1997-1266-121).

Figure 8 taken in 1997 shows the main estuarine channel in the centre, in a similar location to the 1988 image, though perhaps moved to the west. The sand spit on the northwest point of the mouth seems to have shortened (eroded). The prograding beach on the east side of the estuary has reworked into a more defined spit in the centre of the bank, and a small sand bank in the centre seems to have developed at the tip of this. On this photograph there does not seem to be a deep channel adjacent to the erosion site problem area to the west, predominant flow is through the centre of the estuary.

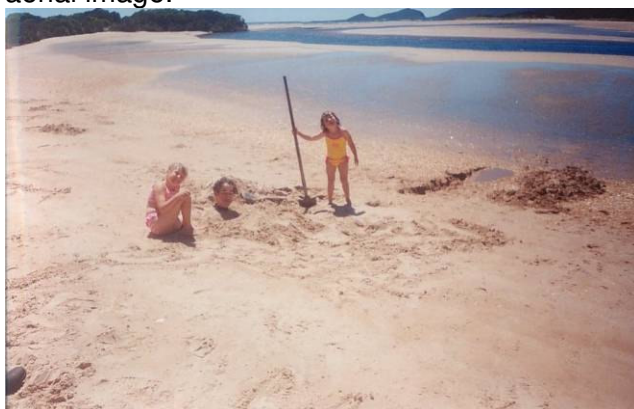
A local resident Mrs Ruth Heathorn (2009) stated that in January 2003 the main estuary channel was running on the eastern side of the estuary with an approximately 30 m foreshore outside the houses on the western shore, shown in Figure 9. The main channel seems here to be perhaps moved west from the 1997 aerial image.

Figure 9: Photo dated January 2003 looking towards the NW point, from the estuary foreshore near the units, showing the Detention River channel in the background (Heathorn, 2009).

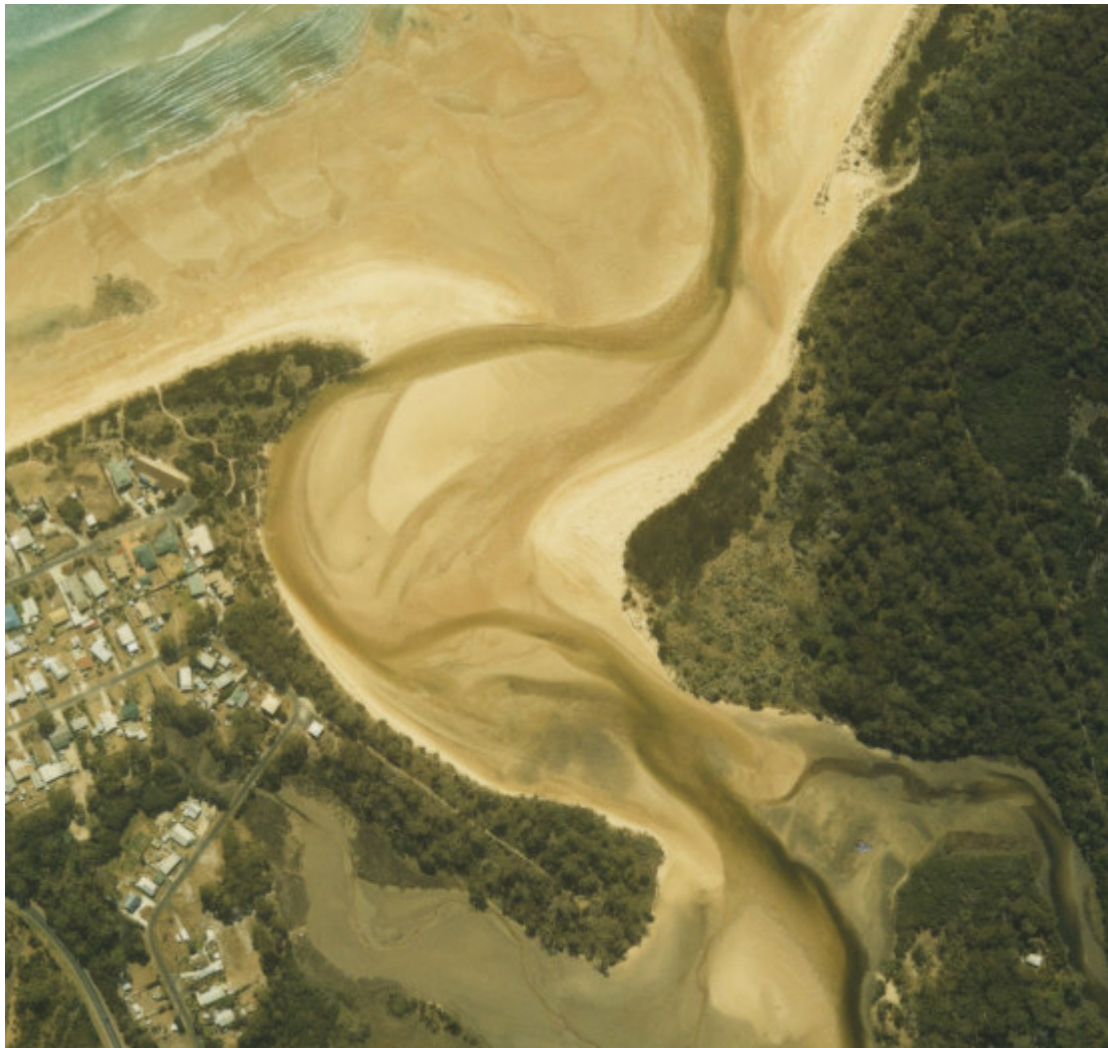
Figure 10. Detention Estuary mouth in 2007 (from DPIPWE image 2007-1420-212).

Figure 10 taken in 2007 shows the main estuarine channel has moved back to near its position in 1968 along the western bank of the estuary mouth, with significant sediment deposits in the centre of the estuary mouth where there was a deep channel in the 1997 image. Parts of this previous central channel are still acting as flood runners at high water. In 2007 relative to 1997 seems to be more exposed pale sand in the mouth of the estuary, such as on the end of the western spit, and in the centre and east of the mouth. Pale sand is usually dry, being supratidal, though this can vary.

Given these reservations, from a geomorphologists' perspective, the channel used to be located in the center of the estuary for a considerable period of time including 1971, 1988, 1997 and perhaps 2003 (Figures 6-9) with no obvious adverse impacts to adjacent beaches. Hence there seems to be no reason why the central channel through the estuary mouth should not be recreated at its former position as shown by the 2003 aerial image in Figure 8. This would relieve ebb water flow pressure on the western bank, as shown in Figure 12, as dredging the pre-existing channel will redirect the passage of water away from the erosion site. French (1997) acknowledges that dredging can change the ebb and flood tide directions and that the system naturally attempts to level out and fill the constructed channel. It is also an expensive option. Therefore such dredging should only be carried out with local supervision from a hydraulic engineer, who may also be able to advise on suitable relocation of the spoil. If this is used to fill in the base of the bank at the western erosion site, then the new channel must be open before this commences otherwise tidal flow will be blocked which may worsen erosion problems.

The full images of the 1997 and 2007 aerial photographs provided by DPIPWE both show ebb dominant deposition features at the mouth of the estuary. This would indicate that any dredging would be most precautionary to commence at the south of the sand bank and progress north, preferably working during falling tide and ceasing work during rising tide. This would prevent sediment washing further up the estuary, but a EIA should further investigate such possible impacts. Similarly, any fill added to the western erosion site is likely to be less hazardous if added from the south towards the north during falling tide, and should be carried out under supervision of a local hydraulic engineer.

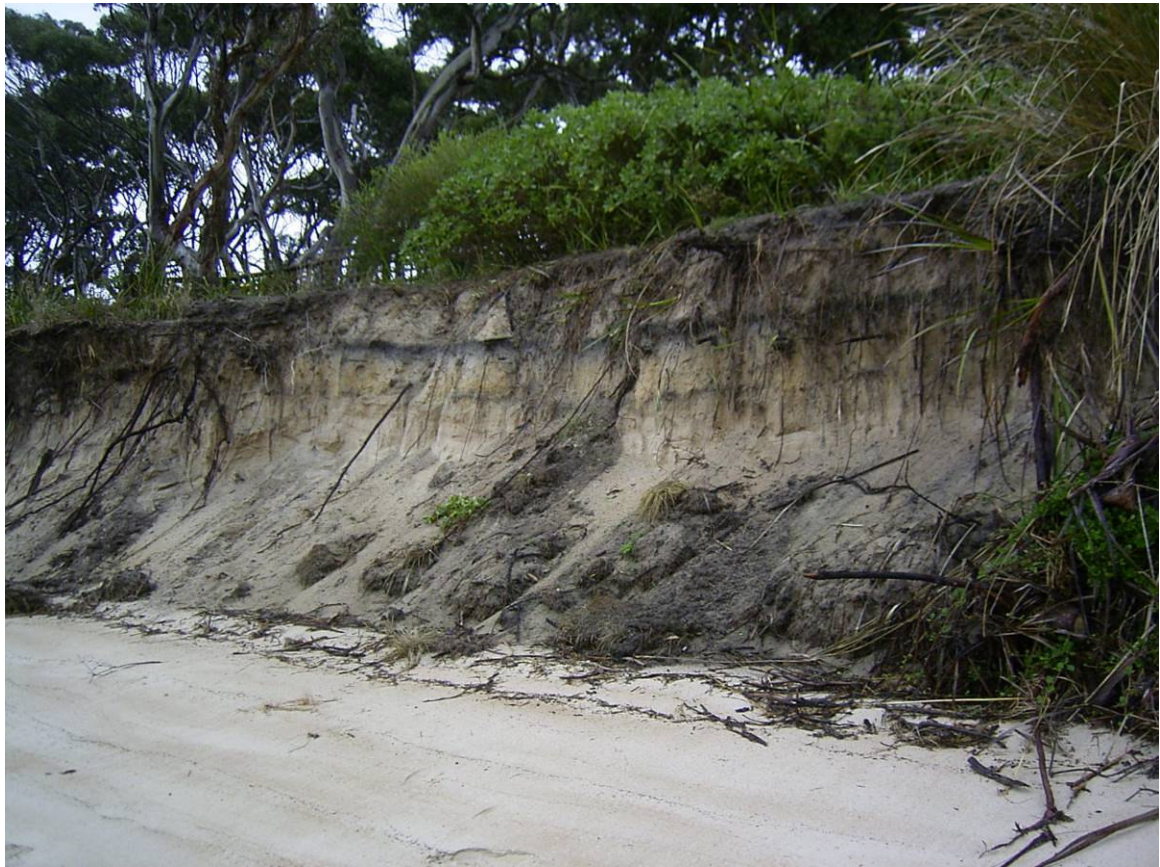
The erosion scarp on the western side of the Detention river estuary extends from the access path from Boobyalla drive for about 300 m seawards. It varies in height from c. 1-3 meters owing to transecting through low dune ridges, and its base is on the margins of the main estuary discharge channel. Exposed paleosols are visible in the erosion scarp (Figure 11), indicating that this is a long established sediment deposit that is now under erosion. Tidal debris and erosion scours at the base of the scarp indicated that tidal currents have direct contact with the erosion scarp, which is of unconsolidated sand. There is no restriction of pedestrian access from either the road of the adjacent properties, and numerous footprints at the top of the scarp were visible on arrival.

Figure 11. Erosion scarp close to the Boobyalla Road access, showing palaeosols embedded, and tidal debris at the base.

Large woody debris at the base of the erosion site has already been partly cleared relative to photographs available from earlier this year. Further removal of large woody debris will assist site stability. Such objects floating at high tide impact the erosion scarp to increase sheer stress, disaggregation and erosion rates. Remaining debris adjacent to the scarp along the beach below should be completely removed with care.

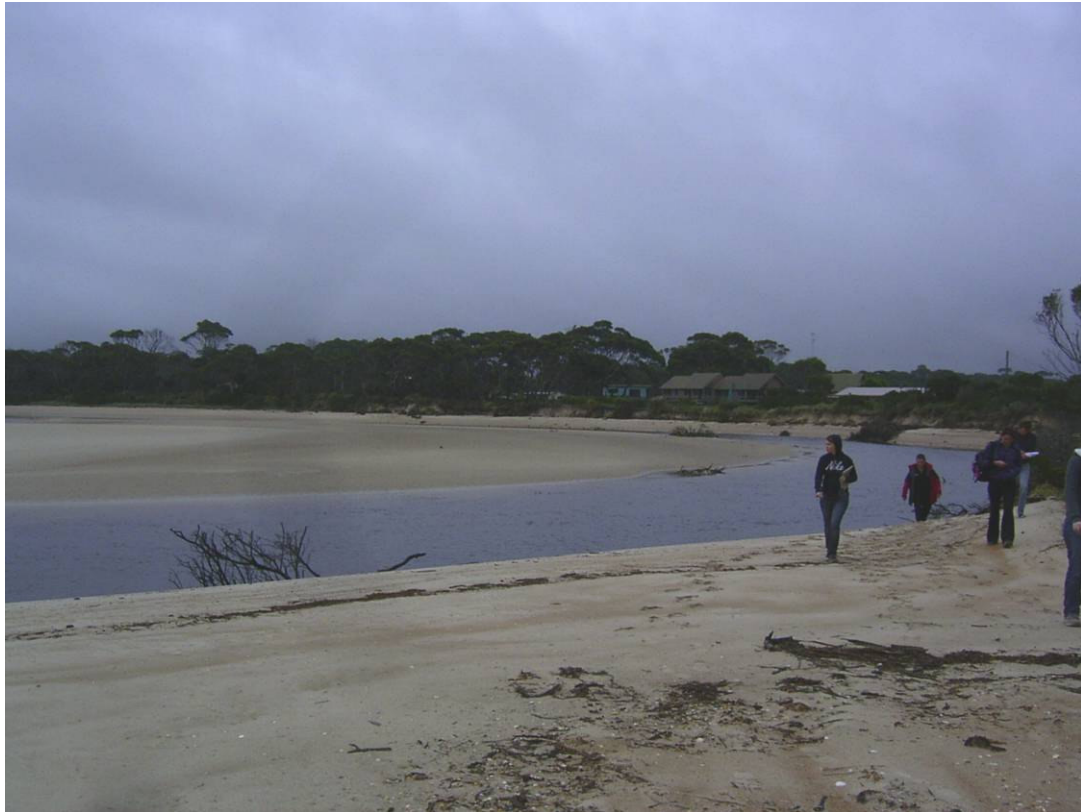
Our visit was at low tide, demonstrating that a large sand bank (Figure 12) occupies the centre to east of the estuary mouth, as shown in the 2007 aerial photograph (Figure 10). The elevation of this appears to approach MSL, below which most flow is confined to the western channel. Observation of the estuarine tidal area south of the erosion site demonstrated that there is a large tidal volume to the south, which may direct significant flows down this more narrow tidal channel closer to the mouth.

Figure 12. View from the NW sandspit point with the erosion scarp on the right bank, showing relative elevation of the central sand deposit seen here above the channel water. This picture was taken about 11.30 am on 23.4.10 during a falling tide to reach a low of 0.61 m at 12.57 pm.

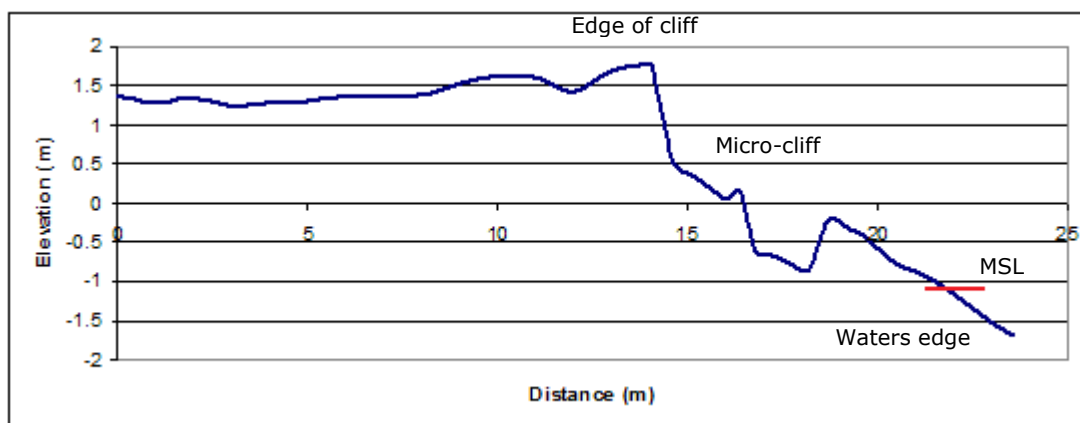
Transect 1 initiated from the property boundary of 49 Honey Richea Road in line with its chimney, facing due east (Figure 4). The total distance of transect 1 as shown in figure 13 covered 23.55 m, and was analysed by the background group in Figure 4. The main scarp face had a total fall of 1.24 m. The micro-cliff had a fall of 0.755 m. Vegetation at the top of the cliff consisted of sedges and ferns including bracken and poa grass. No vegetation was present at the base of the scarp, only a small tuft of weed was present on the top of the micro-cliff. The slope from the base of the micro-cliff to the waters edge is steep at 48.1°.

Figure 13. Cross sectional profile of transect 1 showing main features with mean sea level (MSL).

From the erosion scarp, all three transects showed unconsolidated sand with a steep angle, far greater than the 30° threshold at which the shear strength of the site is reduced (Nichols, 2009). All transects demonstrate concave profile typical of eroding beaches, especially with a microcliff present (Bird, 2000), as shown in Figures 13, 16 and 20.

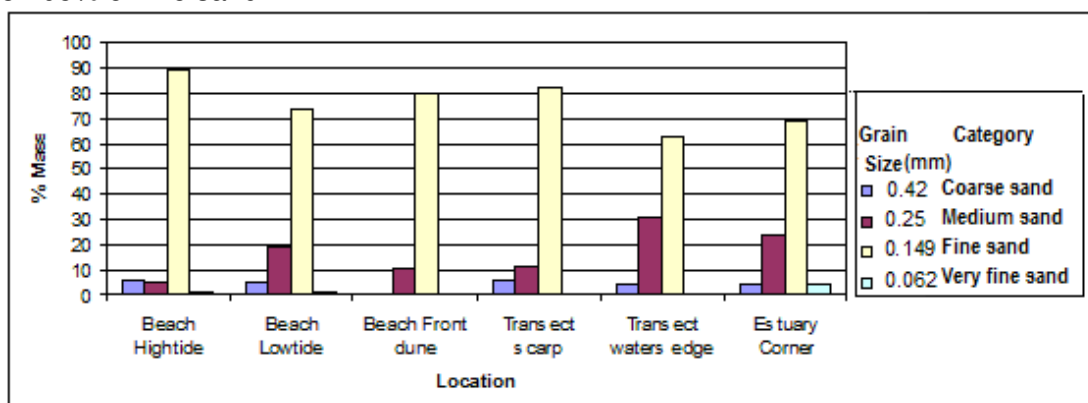
Particle analysis showed grain size to be similar throughout the locations sampled, shown in Figure 14. Grain size 0.149 mm was the dominant particle size which is classified as fine sand based on dimensions of sand found in Nichols (2009). The estuary corner had the most very fine sand (0.062 mm). The transect waters edge had the least proportion of fine sand and the highest proportion of medium sized sand. The transect scarp had lowest proportions of medium and coarse sand, with 82.05% of fine sand.

Figure 14. Percentage particle grain size for transect 1.

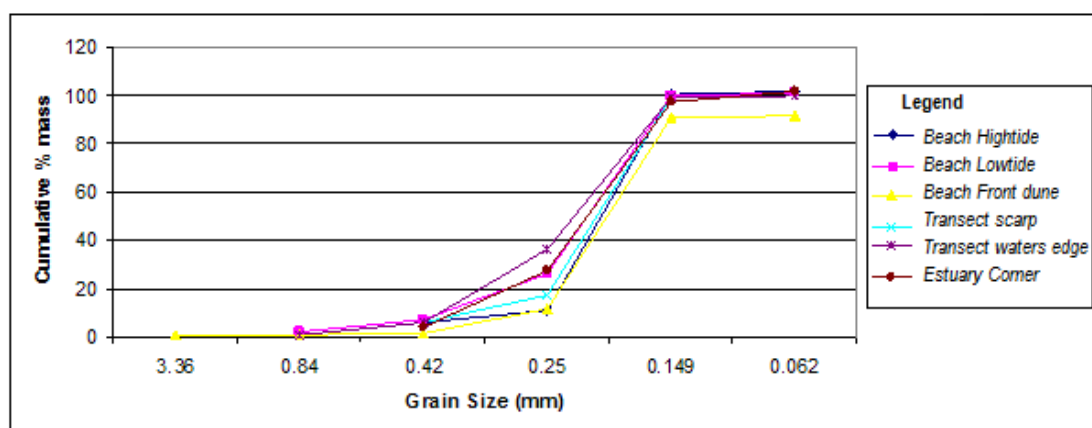
Table 1 shows the cumulative frequencies of the grain size analysis as well as statistical tests that are based on the cumulative curve as shown in Figure 15. The degree of sorting found only the beach at high tide to be very well sorted (0.23). The estuary corner, the beach front dune and transect waters edge were also very well sorted (0.3), while the remaining locations had a value 0.54 which correspond to moderately well sorted sediment.

Figure 15. Cumulative frequency curve of grain size at transect 1.

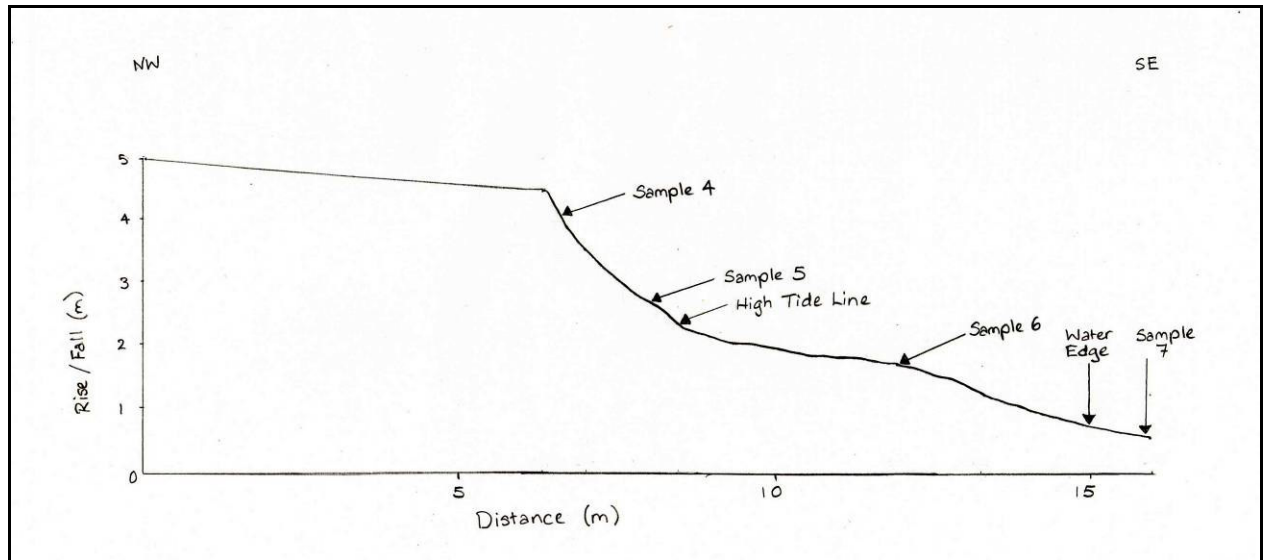
This transect was measured by the foreground group in Figure 4, with a backsighting toward the NW to a telephone pole to act as a secure benchmark for future monitoring of change. The beach profile is illustrated in figure 16, showing the water level at low tide, high tide mark, locations of sediment samples, and the time and date that the transect was recorded. This beach profile has a total fall of 385.5 cm over a distance of approximately 15.8 m, giving a gradient of 0.244.

Figure 16. Profile of transect 2 at Detention River estuary, Hellyer. Transect measurements taken 23rd April 2010 around 1:15 pm.

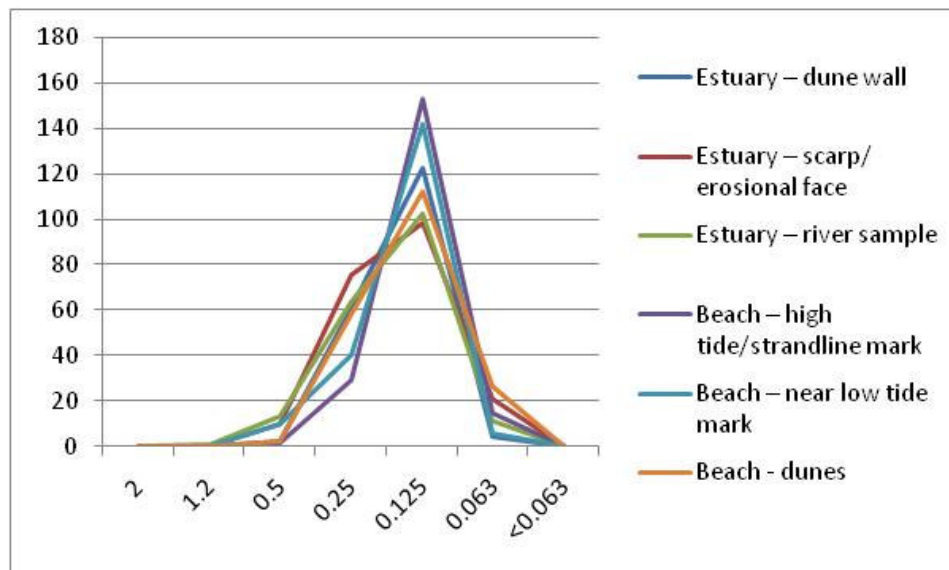
Figure 17: Sediment Grainsize analysis, transect 2.

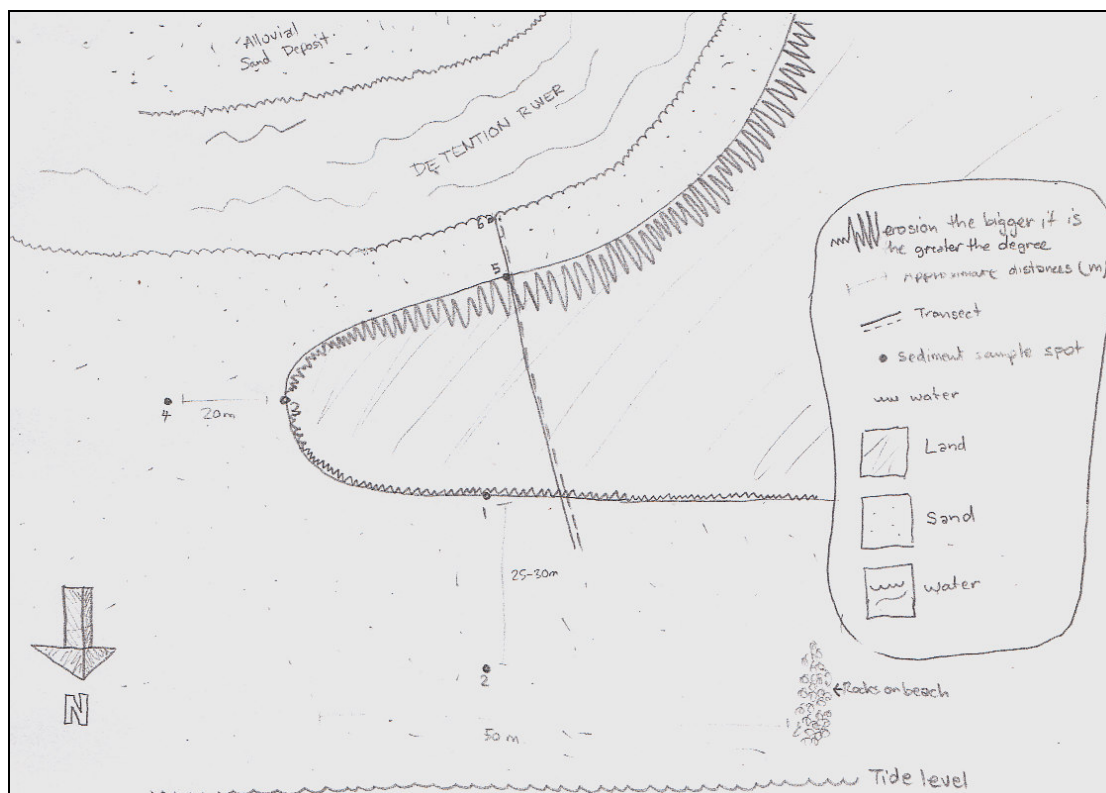
Transect 3 was analysed by the group photographed in the frontispiece picture on the cover page, and was the most seaward transect near the northern margin of the erosion area (Figures 18 and 19).

Figure 18. Plan sketch map of the location of transect 3, and sediment sample locations.

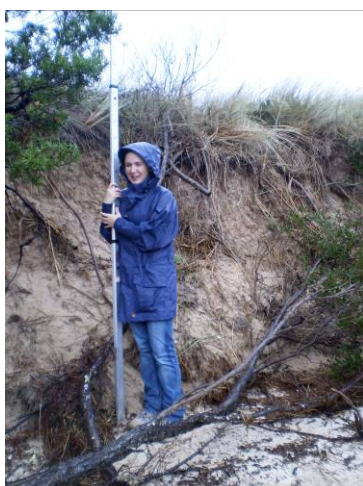
Figure 19. Erosion on the western bank of Detention River at the beginning of transect 3. The transect ran approximately 1 m to the north-eastern side of a sapling that can be seen in the top left hand corner of the photo.

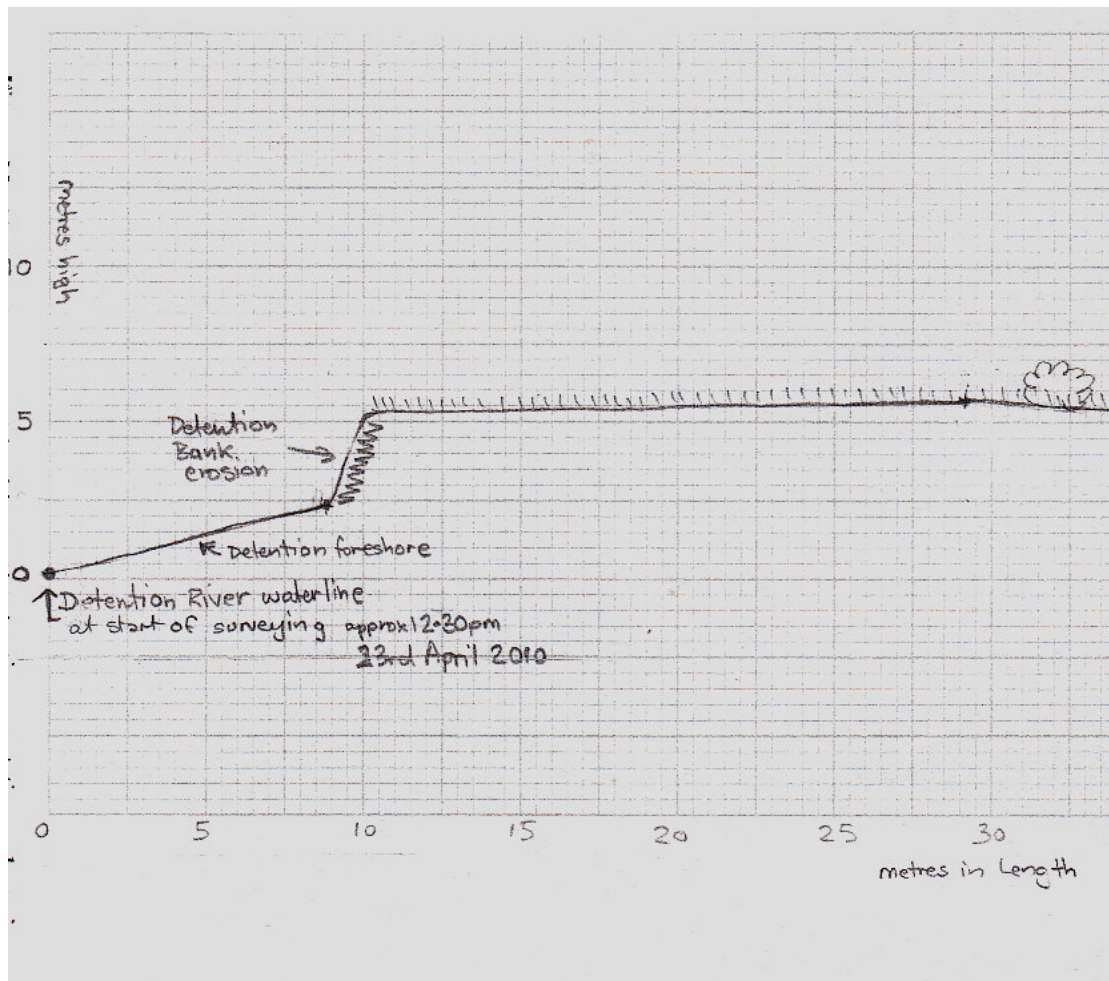
Figure 20. Cross sectional profile of the southern half of transect 3.

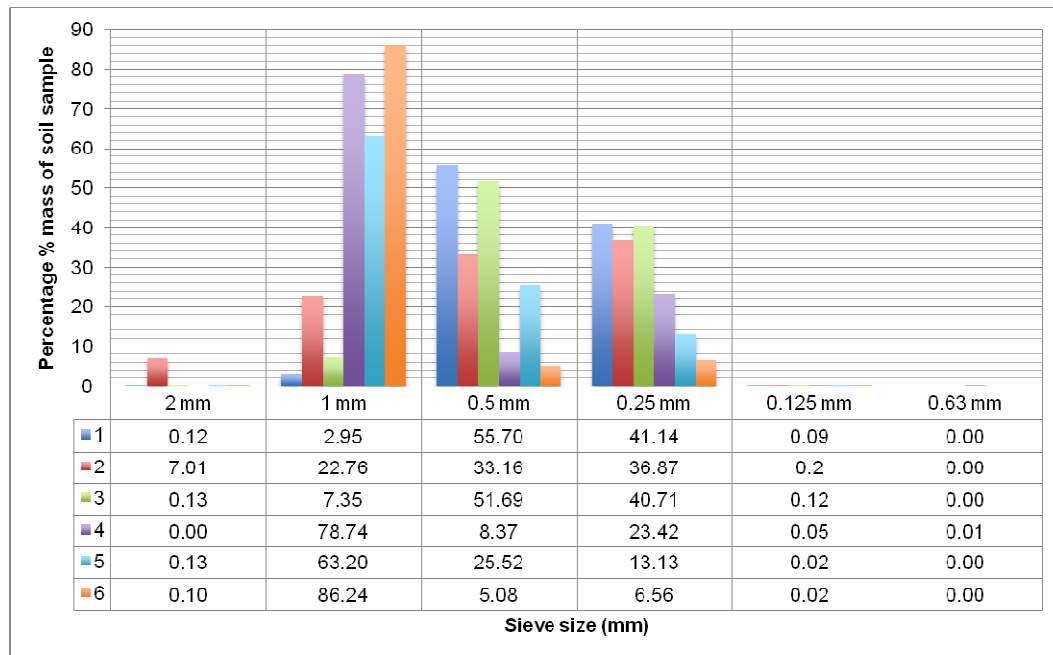
Table 5 shows the grainsize distribution values for each sediment sampled on transect 3 (located in Figure 18), with the results shown in Figure 20. The dominant trend displayed in the graph indicates that there is a wider grainsize variation in the estuarine sediments relative to the beach sediments, meaning that they are less well sorted than those sampled on the beach.

Table 5: Frequency distribution histogram comparing sediment samples from transect 3, values are in grams.

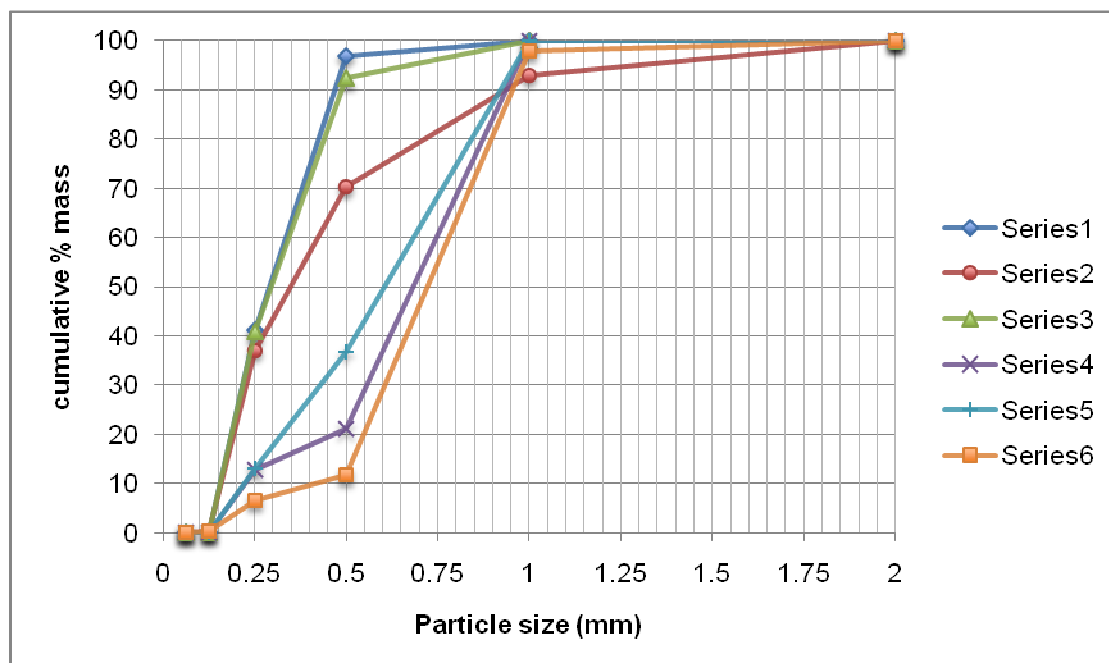
Figure 21. Cumulative frequency curve comparing all sediment samples (key = series 1 is sample 1 etc.)
